Mildmay Community Centre -Certified Passive House

Firat Ucer

The UK's first fully certified non-domestic passivhaus refurbishment

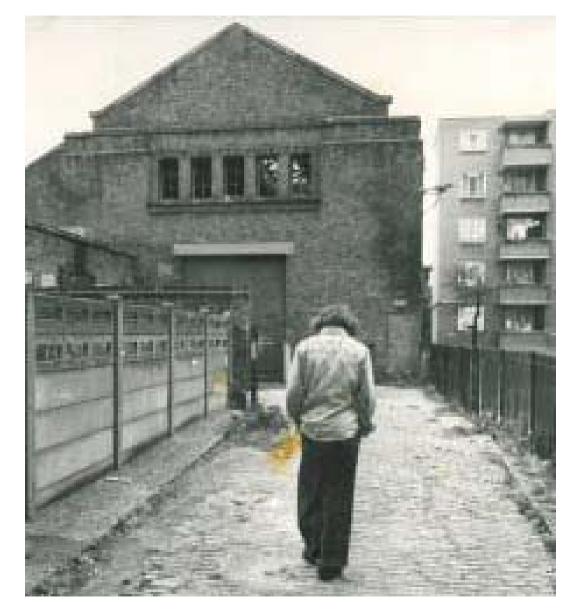
Historic photo before refurbishment

Before refurbishment:

- Un-insulated asbestos roof
- Depressing appearance
- Confusing entrances
- No doors to garden

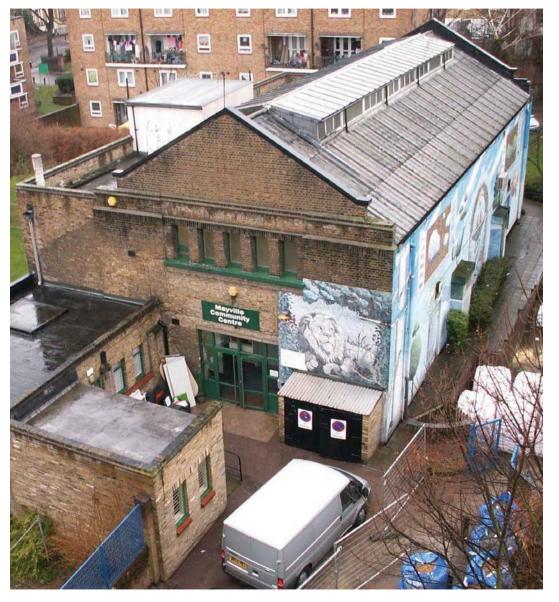
South elevation before refurbishment

Before refurbishment:

- Metal framed, single glazed, draughty windows
- No windows to basement
- Freezing draughts swept across basement from ventilation grilles

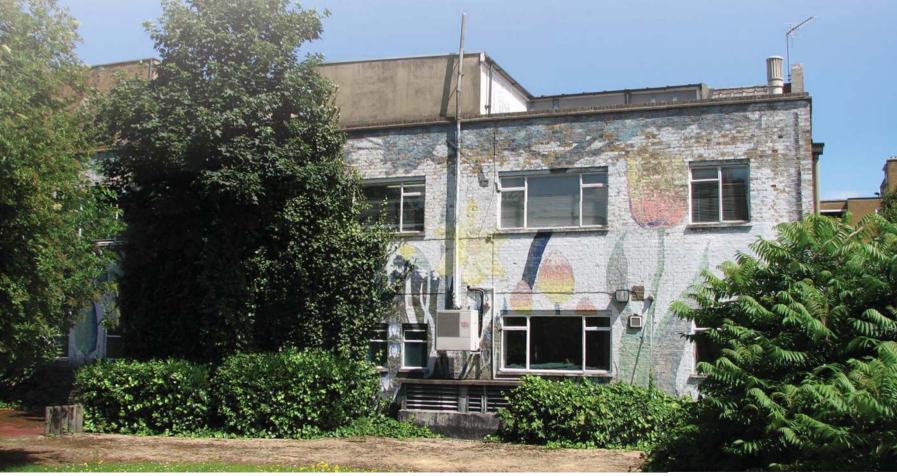
South elevation before refurbishment

Before refurbishment:

- Gloomy, depressing spaces
- Echo made hearing or engaging in conversation difficult particularly for the elderly
- Bad layout and shortage of space
- Freezing cold in Winter!

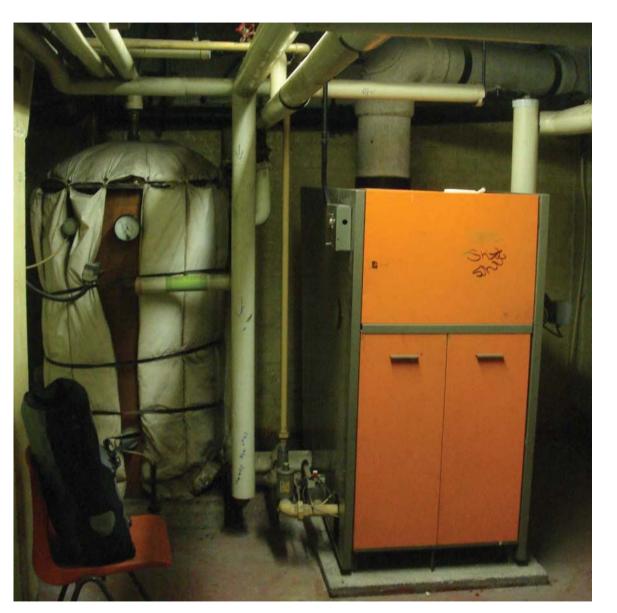
Before refurbishment:

- Difficult to achieve comfortable conditions in winter. Office extension was hot in winter, while main hall was often too cold for sedentary activities, particularly for the elderly
- Total energy demand 581kWh/m²/yr if 21°C winter temps maintained (but 272 kWh/m²/yr in reality due to high energy cost)
- Energy bills over £ 10,000 a year for an organisation with turnover of £60,000 a year

Gigantic gas boiler and virtually un-insulated tank
